Arborist Report

SITE: Marymoor Park Apartments,
6081 East Lake Sammamish Parkway NE, Redmond, WA 98052

RE: Tree Inventory & Assessment

DATE: July 24, 2015

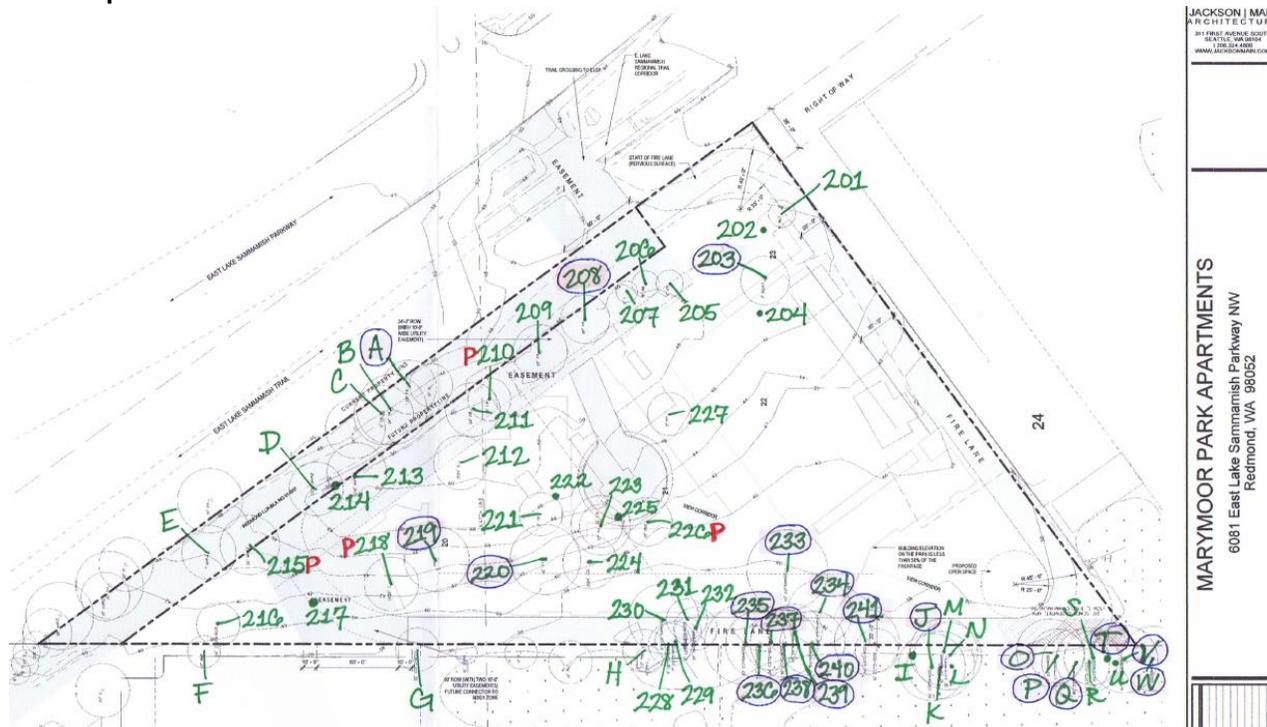
Figure 2: Tree Map – site trees have number identifier, adjacent property trees have letter identifier; Landmark trees have blue circle around identifier, trees in poor health condition have red “P” next to identifier.

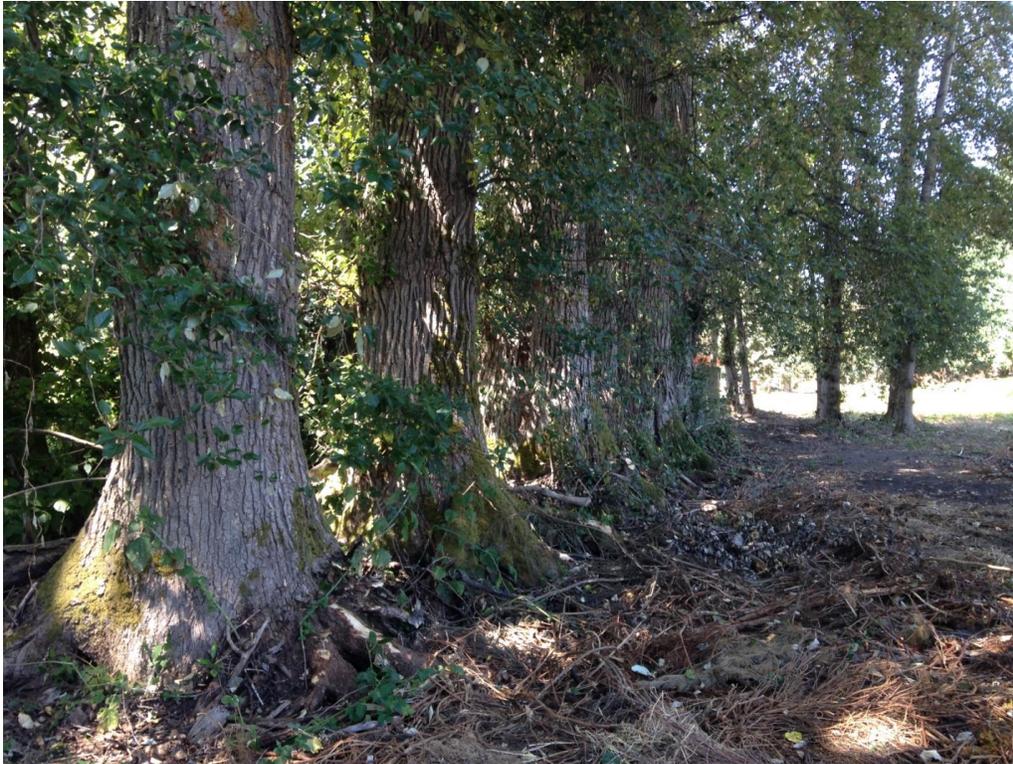
Photo 2: Looking north along western property line at row of large cottonwoods – notice root damage

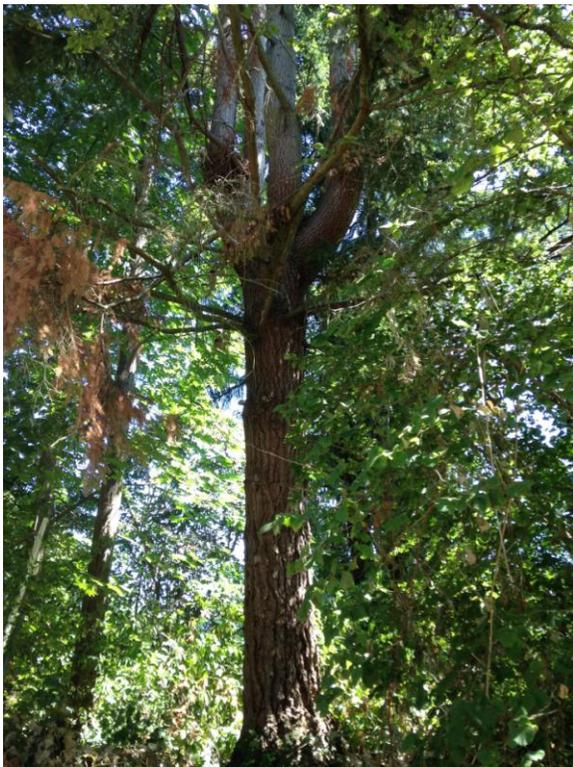
Photo 3: Adjacent site tree A, noted due to structural form resulting from past topping, which may be problematic

Tree ID	Scientific Name	Common Name	DSH (inches)	DSH (multi-stem)	Health Condition	Structural Condition	Drip Line (feet)	Proposed Action	Notes
A	<i>Pseudotsuga menziesii</i>	Douglas-fir	30.5		Good	Fair	26	Remove	Previously topped at 20 feet; three re-iterations; no follow-up management was completed; attachment are stable currently, but advanced testing in recommended if retained; overhangs subject property by 2 feet
B	<i>Pseudotsuga menziesii</i>	Douglas-fir	25.6		Good	Fair	27	Remove	Previously topped at 20 feet; three re-iterations; no follow-up management was completed; attachment are stable currently, but advanced testing in recommended if retained; overhangs subject property by 3 feet
C	<i>Pseudotsuga menziesii</i>	Douglas-fir	16.2		Good	Fair	26	Remove	Topped previously; overhangs site by 2 feet
D	<i>Acer macrophyllum</i>	Bigleaf maple	13.8	15.5, 12.0, 15.0, 12.5	Fair	Poor	32	Remove	Co-dominant from based with 7 stems; three large dead stems and unstable; Kretschmaria deusta found at base; dead parts throughout; overhangs site by 8 feet

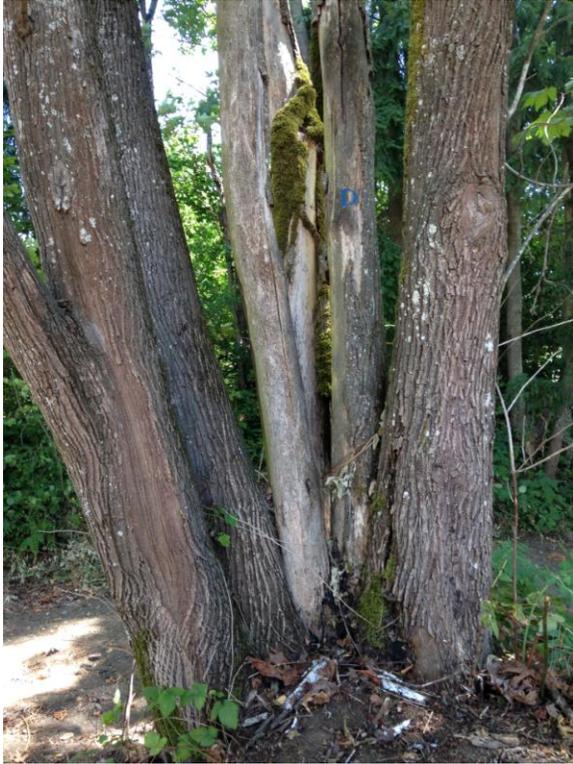
Photo 4: Adjacent site tree D, just beyond northeastern property line, also has problematic form with multiple stems crowded at basal attachment – several of the bigleaf maple trees on site have similar issues.`
