**Arborist Report**

TO: Lowe Enterprises, Inc.  
SITE: NE 74<sup>th</sup> St & 168<sup>th</sup> Ave NE, Redmond, WA 98052  
RE: Tree Inventory & Assessment  
DATE: December 7, 2015  
PROJECT ARBORIST: Katie Hogan, ISA Certified Arborist PN-8078A  
ASSISTED BY: Haley Galbraith, ISA Certified Arborist PN-7512A  
ISA Qualified Tree Risk Assessor

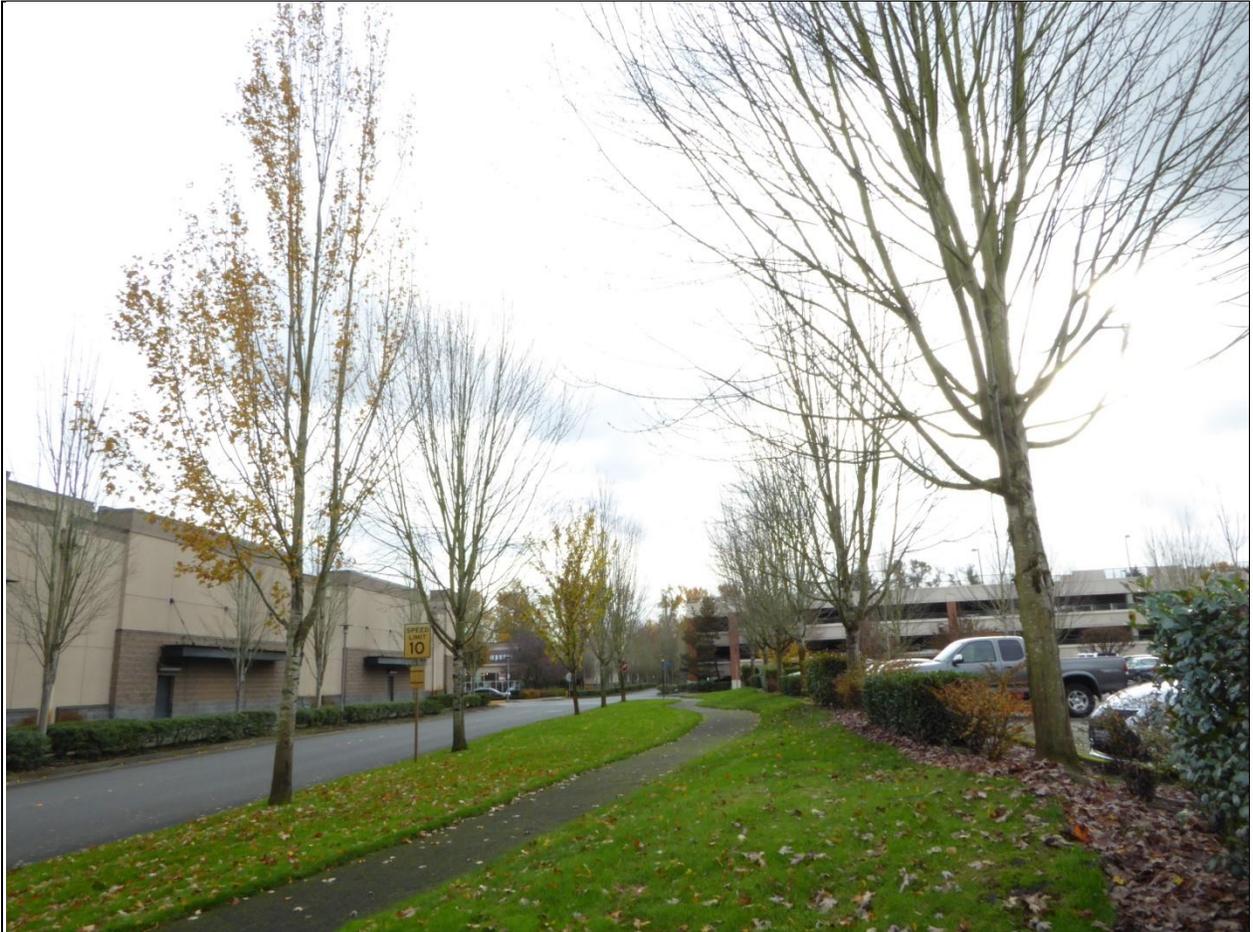
The trees along 168<sup>th</sup> Ave NE were in fair to good health and structural condition. These trees are unlikely to be compromised during site development if careful construction practices are implemented that do not over-excavate or encroach into the critical root zones of these trees. Depending on the extent of disturbance for the proposed structure, it is possible that trees planned for retention may be considered impacted per RZC.

**Photo 1:** Trees along 168<sup>th</sup> Ave NE proposed for retention (on left). Trees in relatively good health and structure and are good long-term trees for this site.

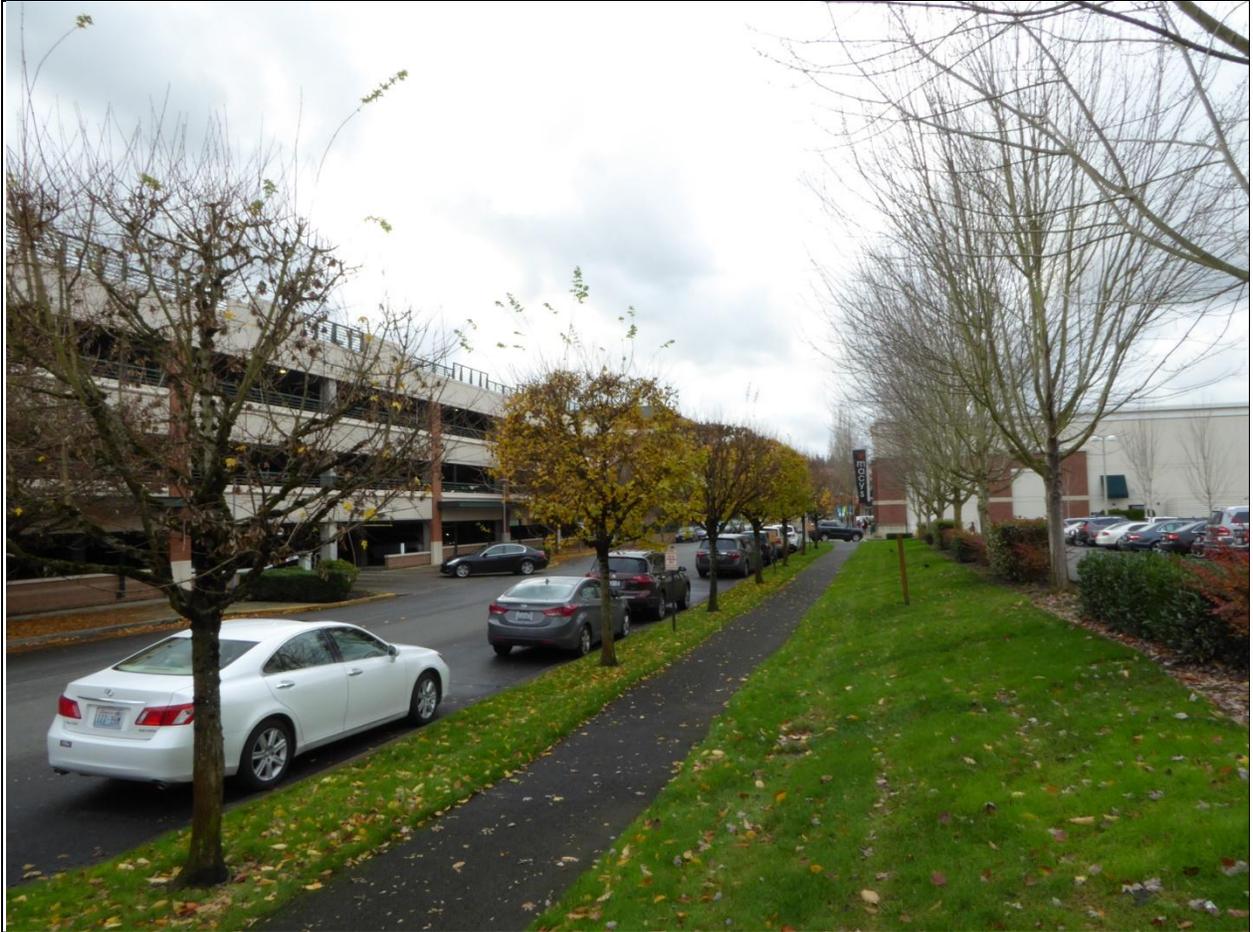
The hedge maple trees along NE 74<sup>th</sup> street have been repeatedly topped to achieve a pollarded aesthetic. As a result, the branches had re-sprouted with multiple weakly attached shoots. The trees also appeared to be declining in health, as indicated by areas of foliar dieback.

The hedge maple trees along NE 74<sup>th</sup> St were declining in health and structural condition. The trees were pruned in a way that will require regular pruning maintenance. While they do not present high risk to surrounding targets, it may better suit the long-term vision of this right-of-way to remove and replace these trees with healthy trees. We recommend taking this opportunity to amend the soil conditions prior to planting new trees along this strip.

**Photo 2:** Trees along NE 74<sup>th</sup> St that have been repeatedly topped (on left). Trees are not ideal long-term trees for this site.

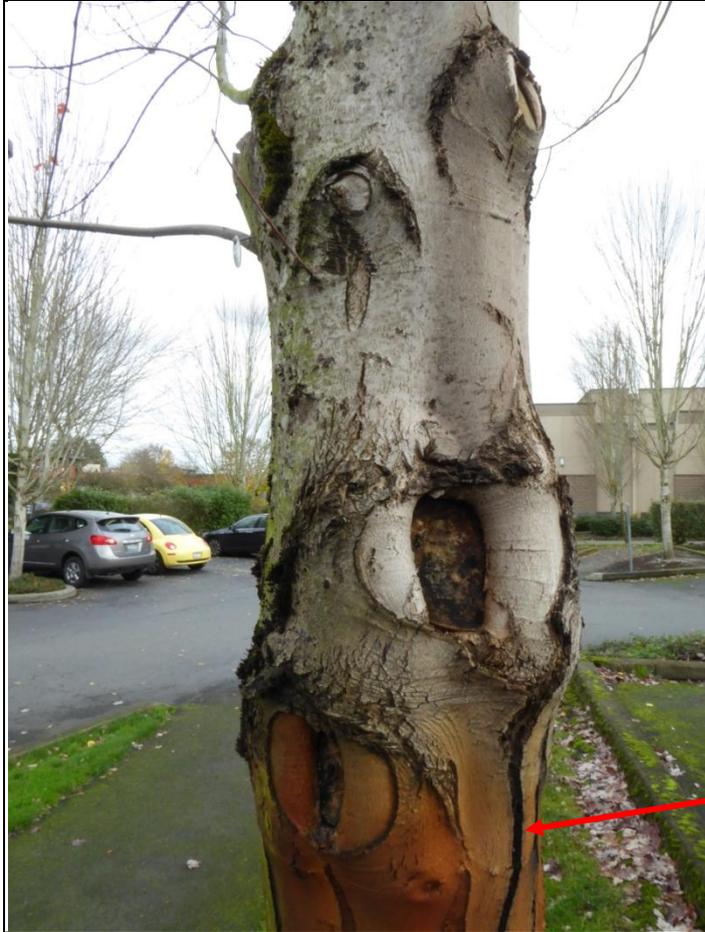
None of the trees had severe structural defects, but most of them had a multi-stem form that branched above standard height. The trees all had a history of pruning, including crown raising for parking and roadway clearance. Much of the past pruning we observed appeared to have been carried out improperly, as indicated by large flush cut wounds. Some pruning wounds were fully occluded with new growth, while others did not have adequate response growth and decay had begun forming.

Several trees had what appeared to be vertical freeze-thaw cracks along the basal trunks. These cracks did not seem to be negatively impacting the health or stability of the trees.

**Photo 3:** Large pruning cut wounds and what appeared to be freeze-thaw cracking (red arrow).
