Draft Environmental Assessment Memorandum: Downtown Study Area

GeoEngineers

Subject: Draft Preliminary Environmental Assessment
BNSF Rail Corridor Master Plan, Downtown Study Area
Redmond, Washington
GeoEngineers File No. 0500-172-00

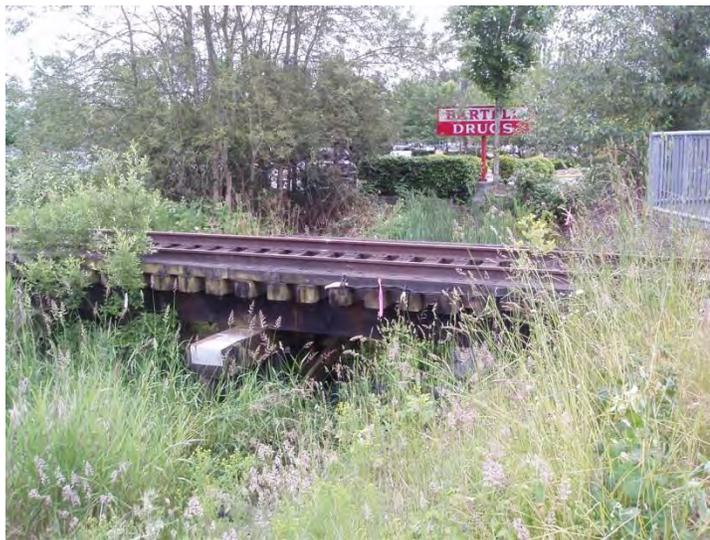
Photo 1. Elevated timber span above Wetland A.

As illustrated in Photo 1 and mapped in Figure 4, the BNSF tracks span Wetland A on an approximately 20-foot long elevated timber bridge. Improvements to this span may result in direct impacts to Wetland A, such as temporary construction impacts and/or impacts from shade. The City of Redmond may require mitigation for these impacts once they are identified.

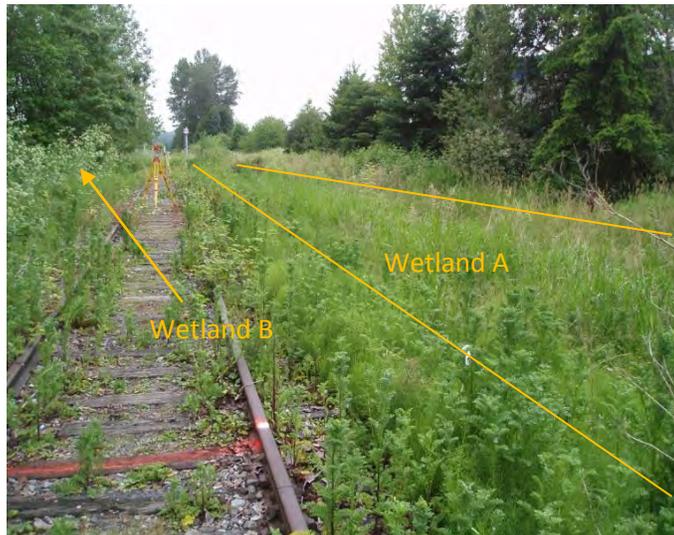
Photo 2. Photo showing the locations of Wetlands A and B relative to the BNSF Rail prism.

Like Wetland A, Wetland B is located in a closed depression that likely receives runoff from the abutting impervious surfaces. As a result, functional assessment and rating scores of Wetland B are very similar to Wetland A. Wetland B scores 16 for water quality functions, 16 for hydrologic functions and 8 for habitat functions. The total score of 40 designates Wetland B as a Category III wetland. Because of the low level habitat functions that this wetland performs, the City of Redmond requires an 80-foot protective buffer for this Category III Wetland, in accordance with RMC 20D.140.30-020(2).

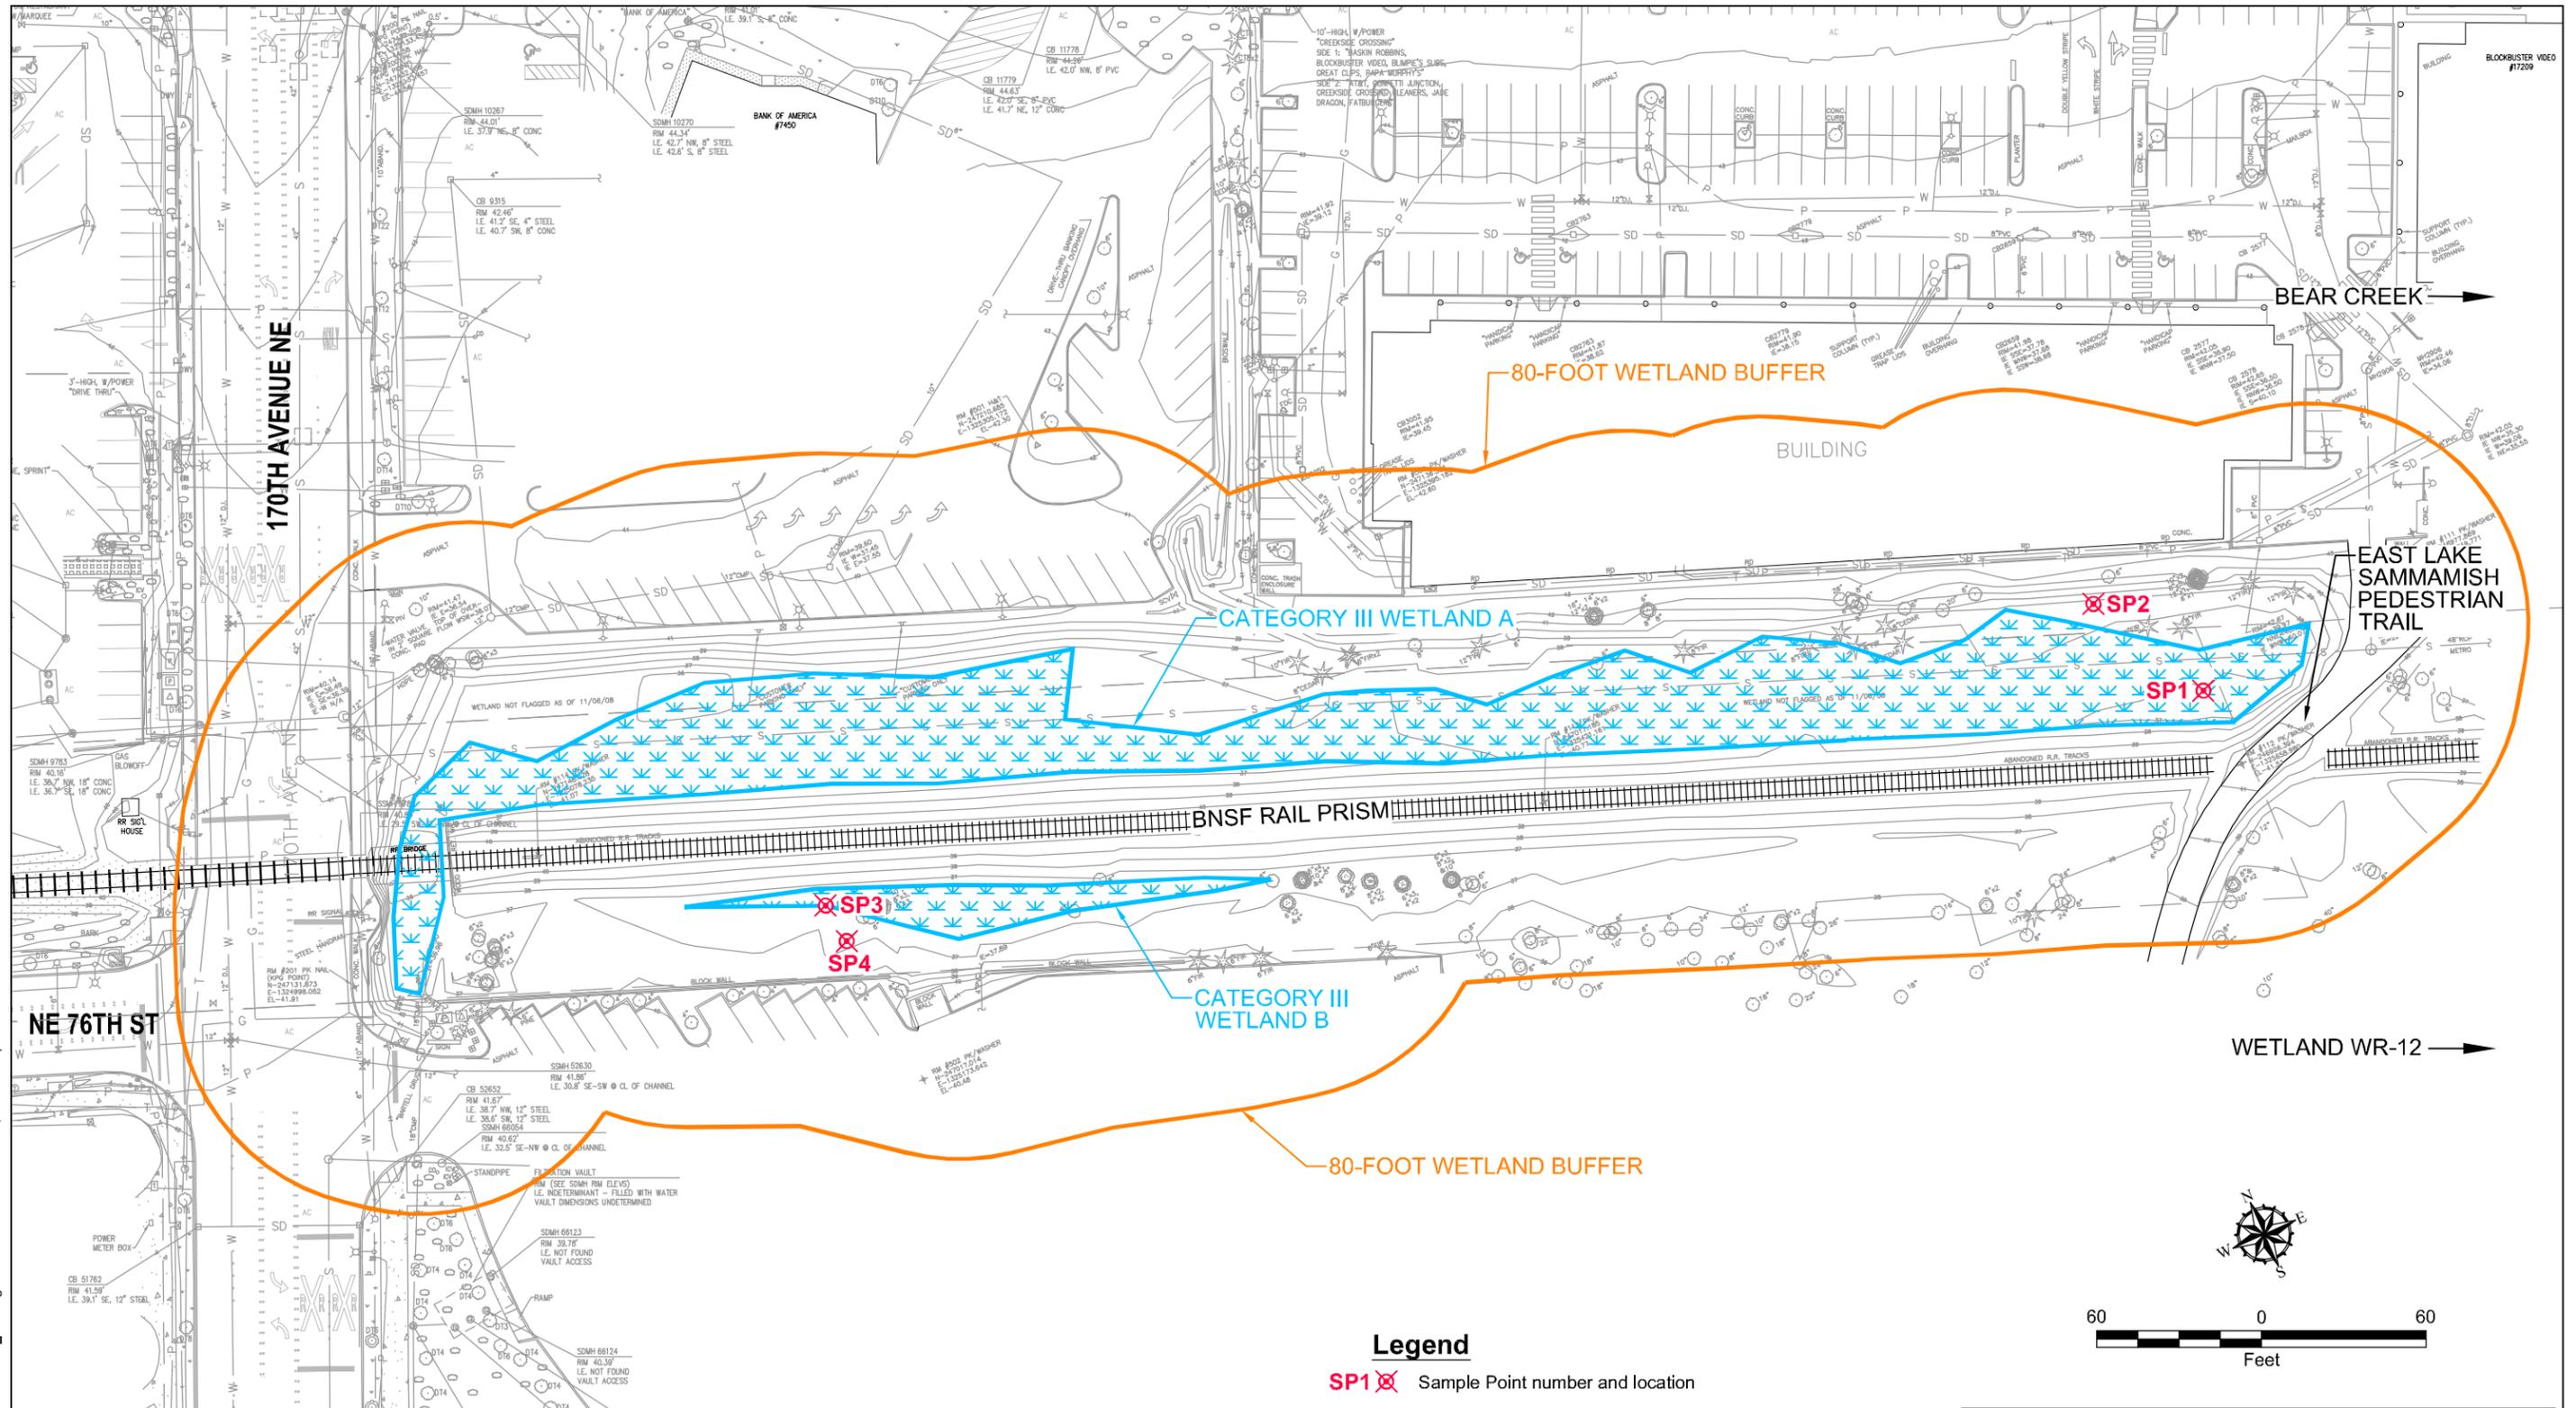
Positive indicators of hydric soils were observed within a 16-inch deep test pit (SP-1), including a depleted matrix, within the wetland boundary (USACE, 2008). The locations of test pits are mapped on Figure 4.

Two on-site wetlands (Wetlands A and B) were delineated (Figure 4). One additional wetland (WR-12) is located west of the Downtown Study Area corridor (CH2M Hill, 2008) and one potential wetland was observed adjacent to the western end of the corridor (Figure 5). This potential wetland is located at the toe of a Landslide Hazard Area associated with the BNSF fill prism near the Sammamish River.

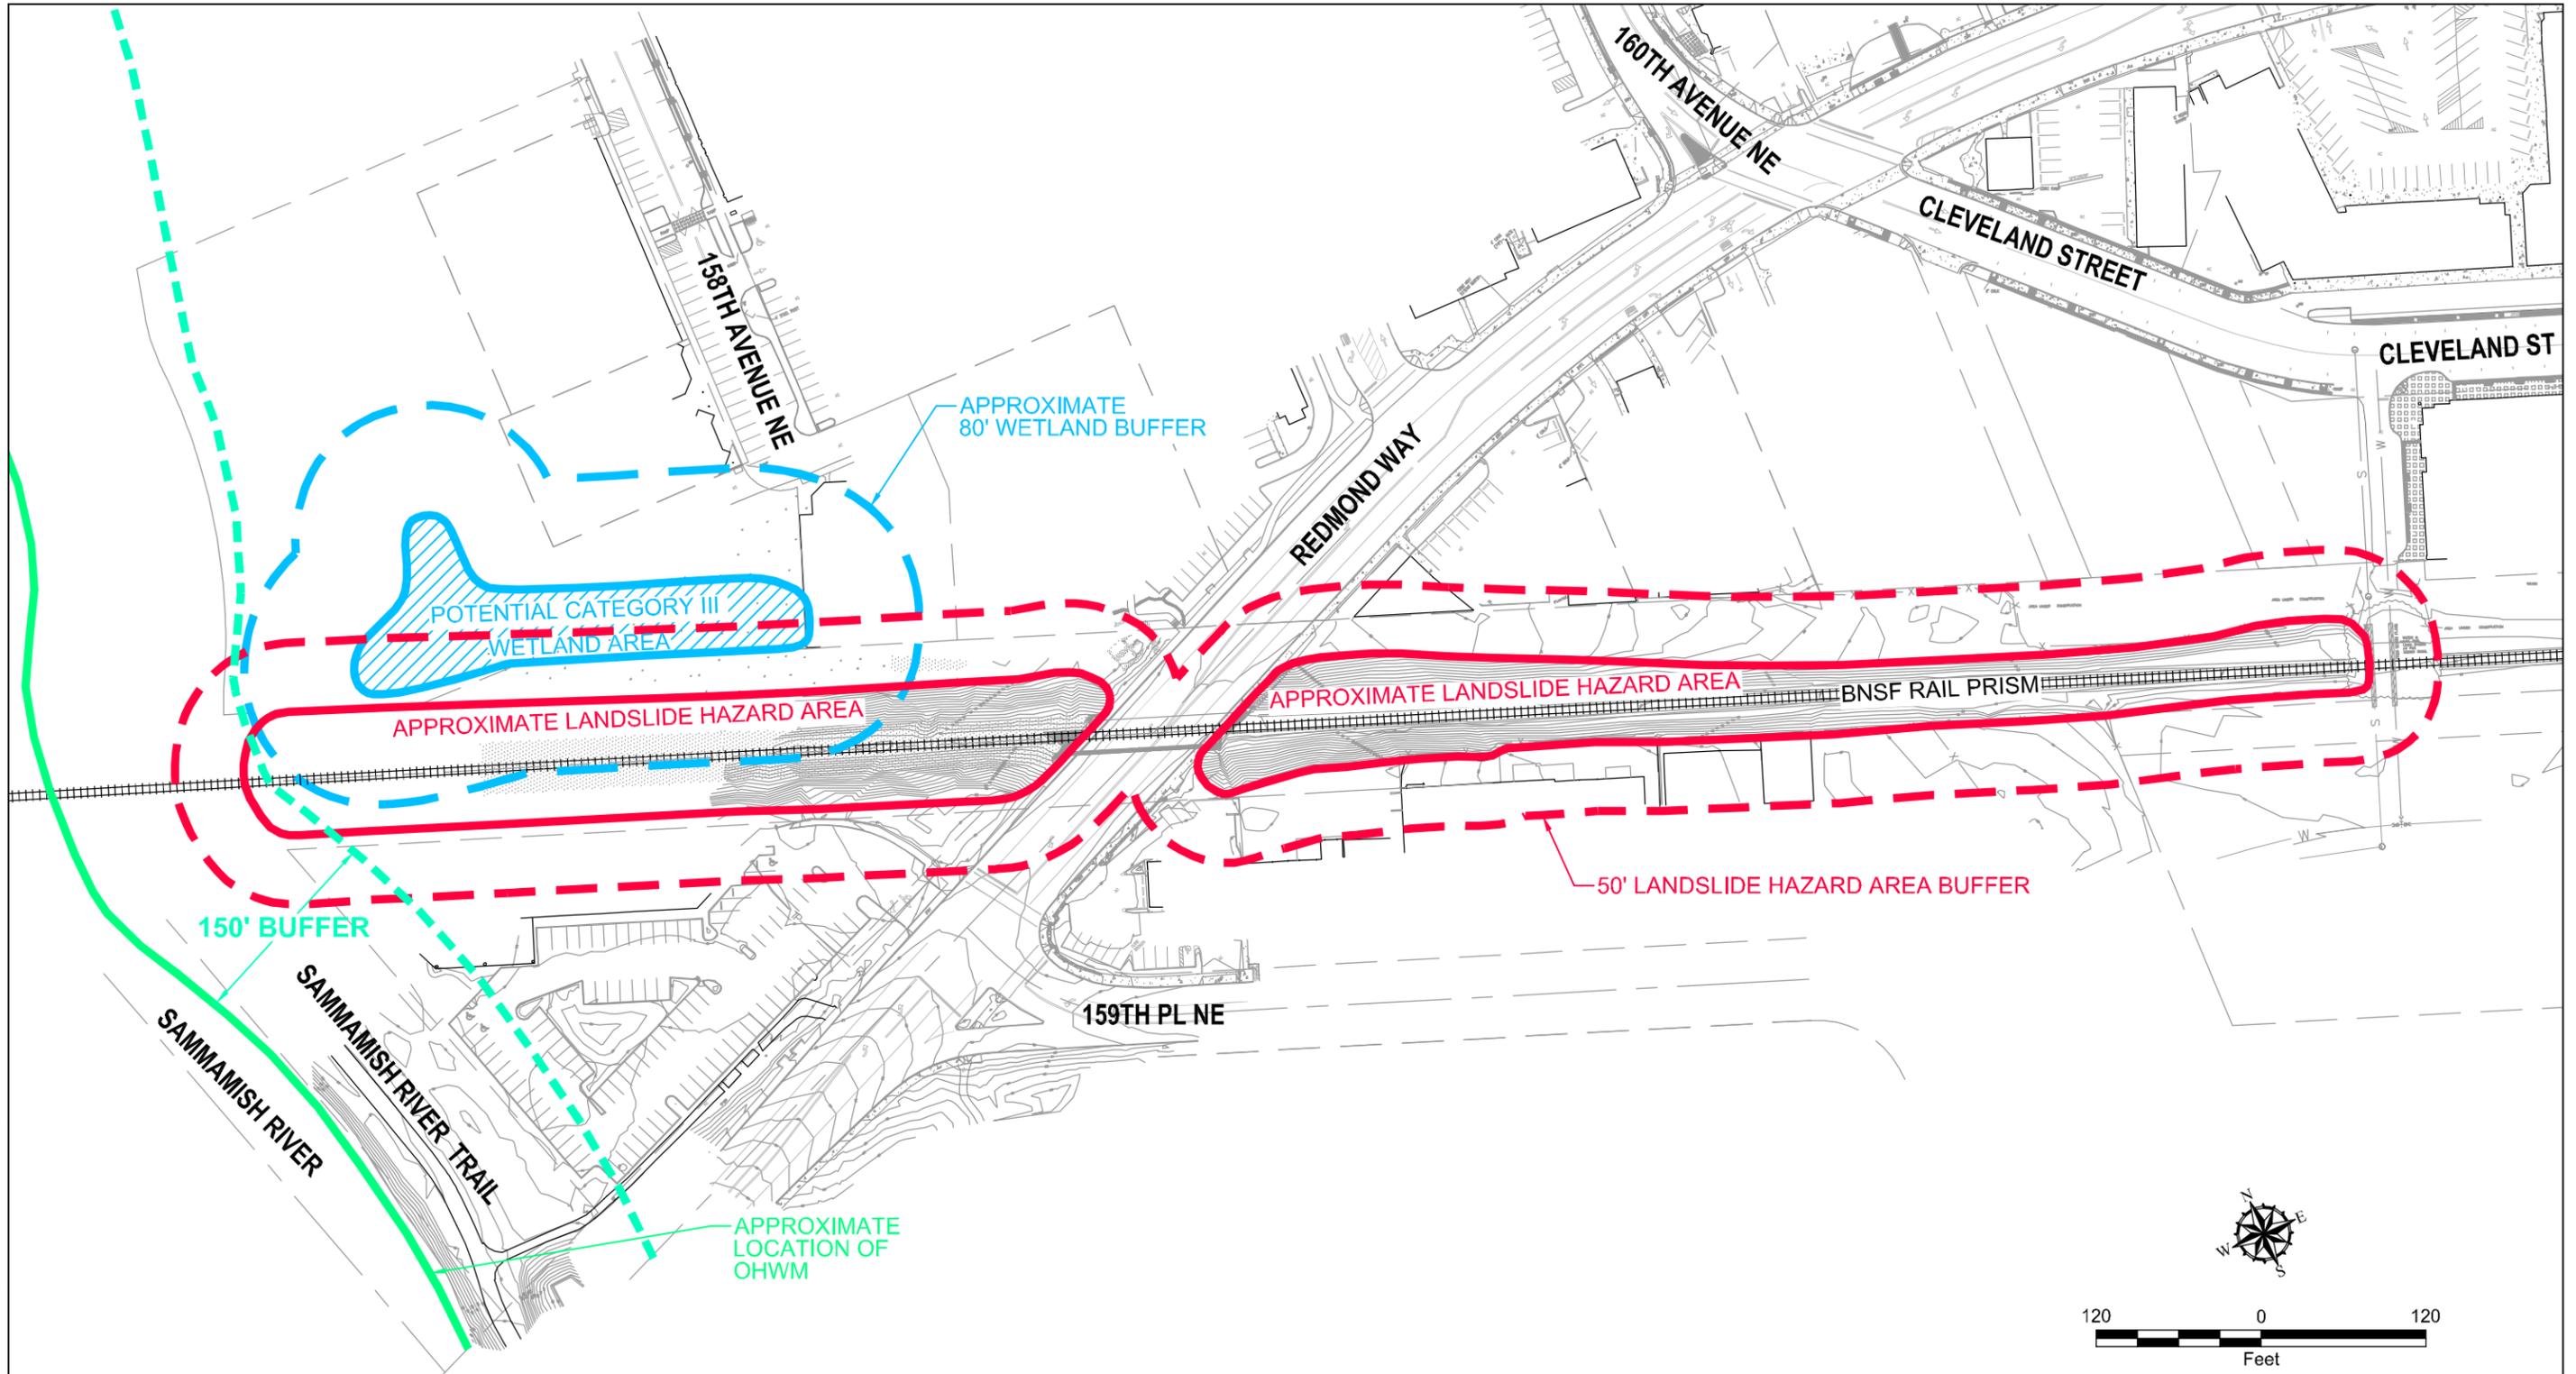
Map of Steep Slopes and Sammamish River

The City of Redmond (2010) does not indicate the presence of any Erosion Hazard or Landslide Hazard Areas within the Downtown Study Area corridor. The slopes along the BNSF fill prism along

the western end of the Downtown Study Area corridor are steeper than 40-percent and have a vertical relief greater than 10 feet. Under RMC 20D.140.60-010(1)(b)(vii), these areas are regulated as Landslide Hazard Areas. According to RMC 20D.140.60-020, a 50-foot buffer shall be measured from the top, toe and sides of the Landslide Hazard Area. Under RMC 20D.140.10-030(1)(d), redevelopment of the trail in the Landslide Hazard Areas may be exempt from provisions of the Critical Areas Ordinance provided that there is no increase in the amount impervious surface. Additionally, a geotechnical evaluation may be required to identify the risks of damage from the proposal, both on-site and off-site, to ascertain that the proposal will not increase the risk of occurrence of the potential geologic hazard; and to identify measures to eliminate or reduce risks.

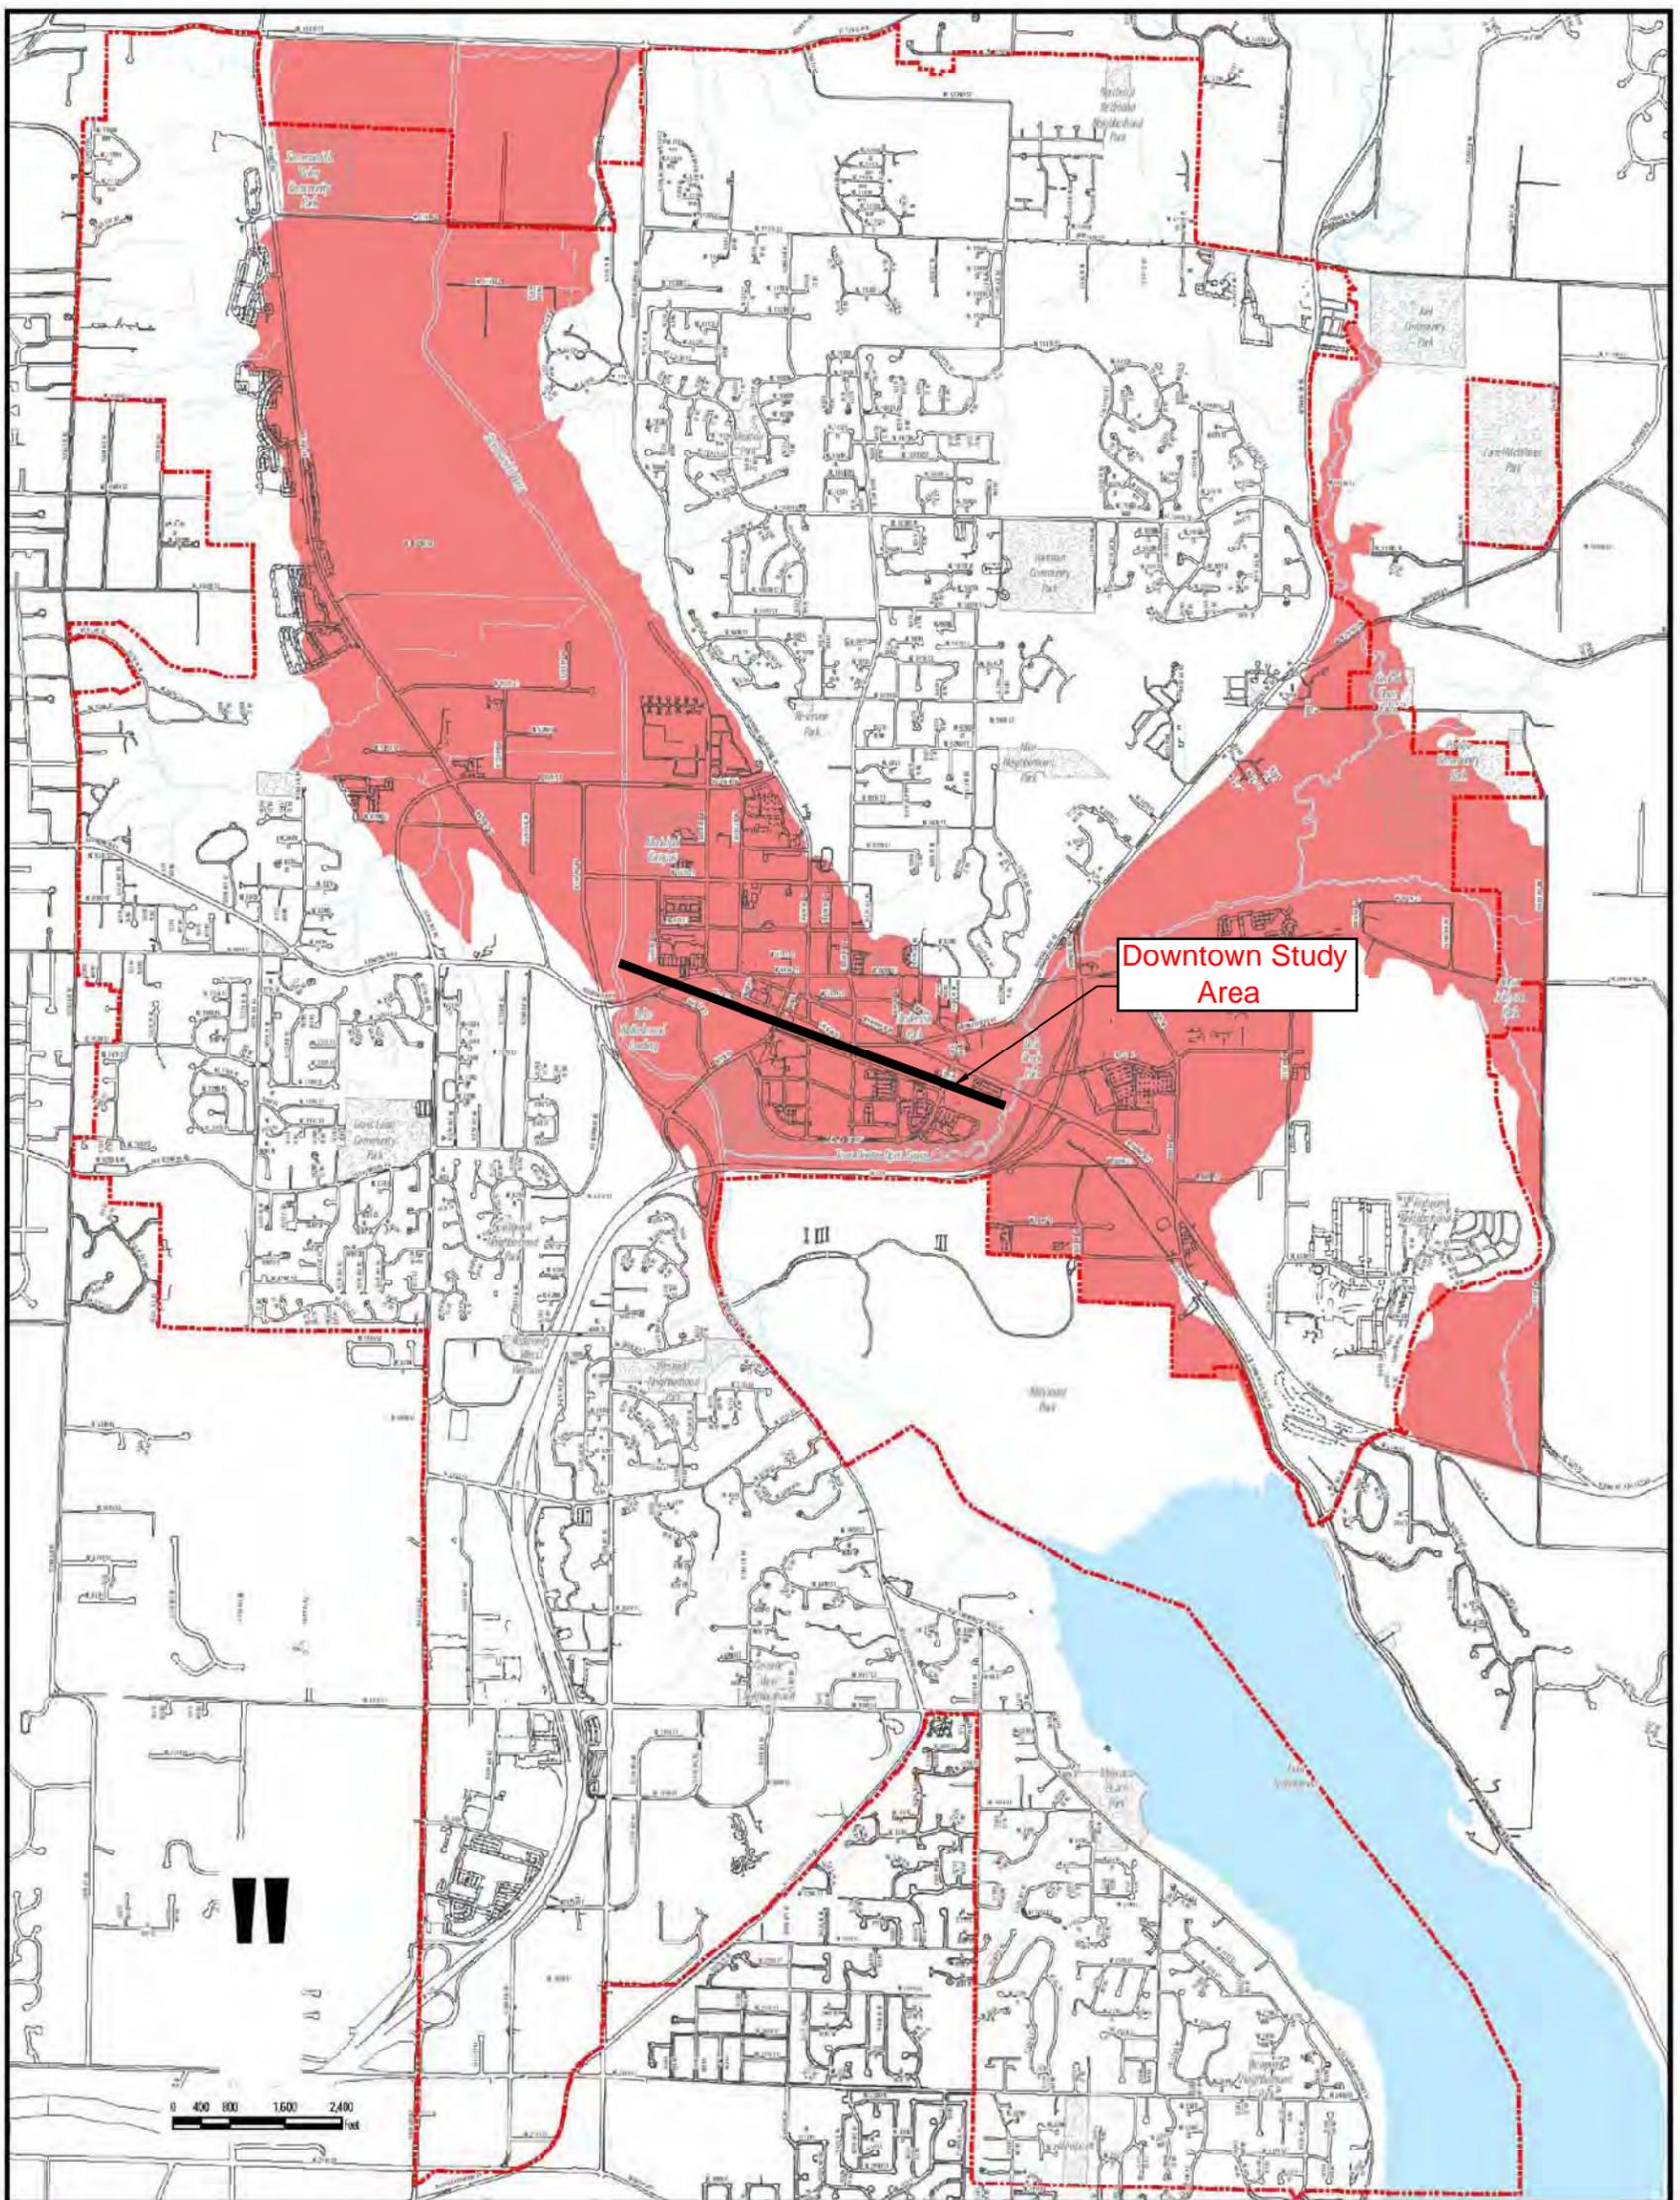
Seismic Hazard Areas	
BNSF Rail Corridor Master Plan Redmond, Washington

Seismic Hazard Areas are ubiquitously mapped in the relatively level areas associated with the valleys that contain Lake Sammamish, the Sammamish River, Bear Creek and Evans Creek (Figure 8).

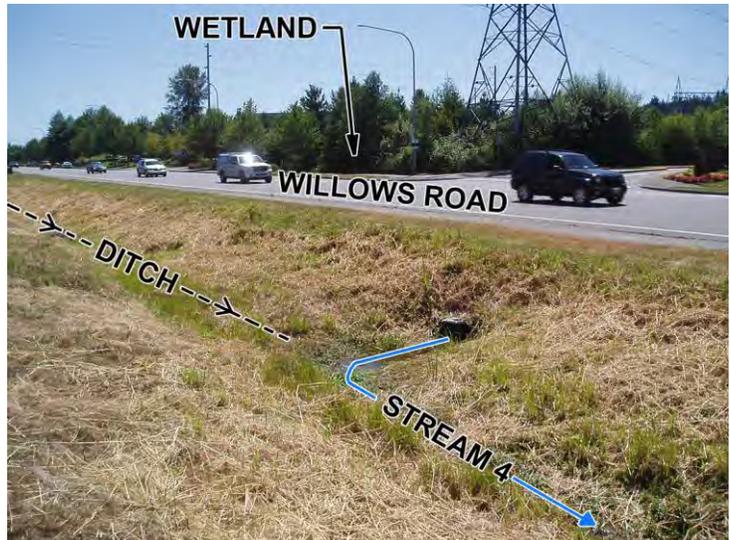
Photo 1. Typical conditions west of the BNSF ROW.

Because of the adjacent land use, these open stream sections have been channelized and, generally, parallel the BNSF rail prism in maintained ditches. Stream crossings through the rail prism are via concrete box culverts, corrugated metal pipes and/or concrete pipes. As a result, riparian habitat is heavily degraded.

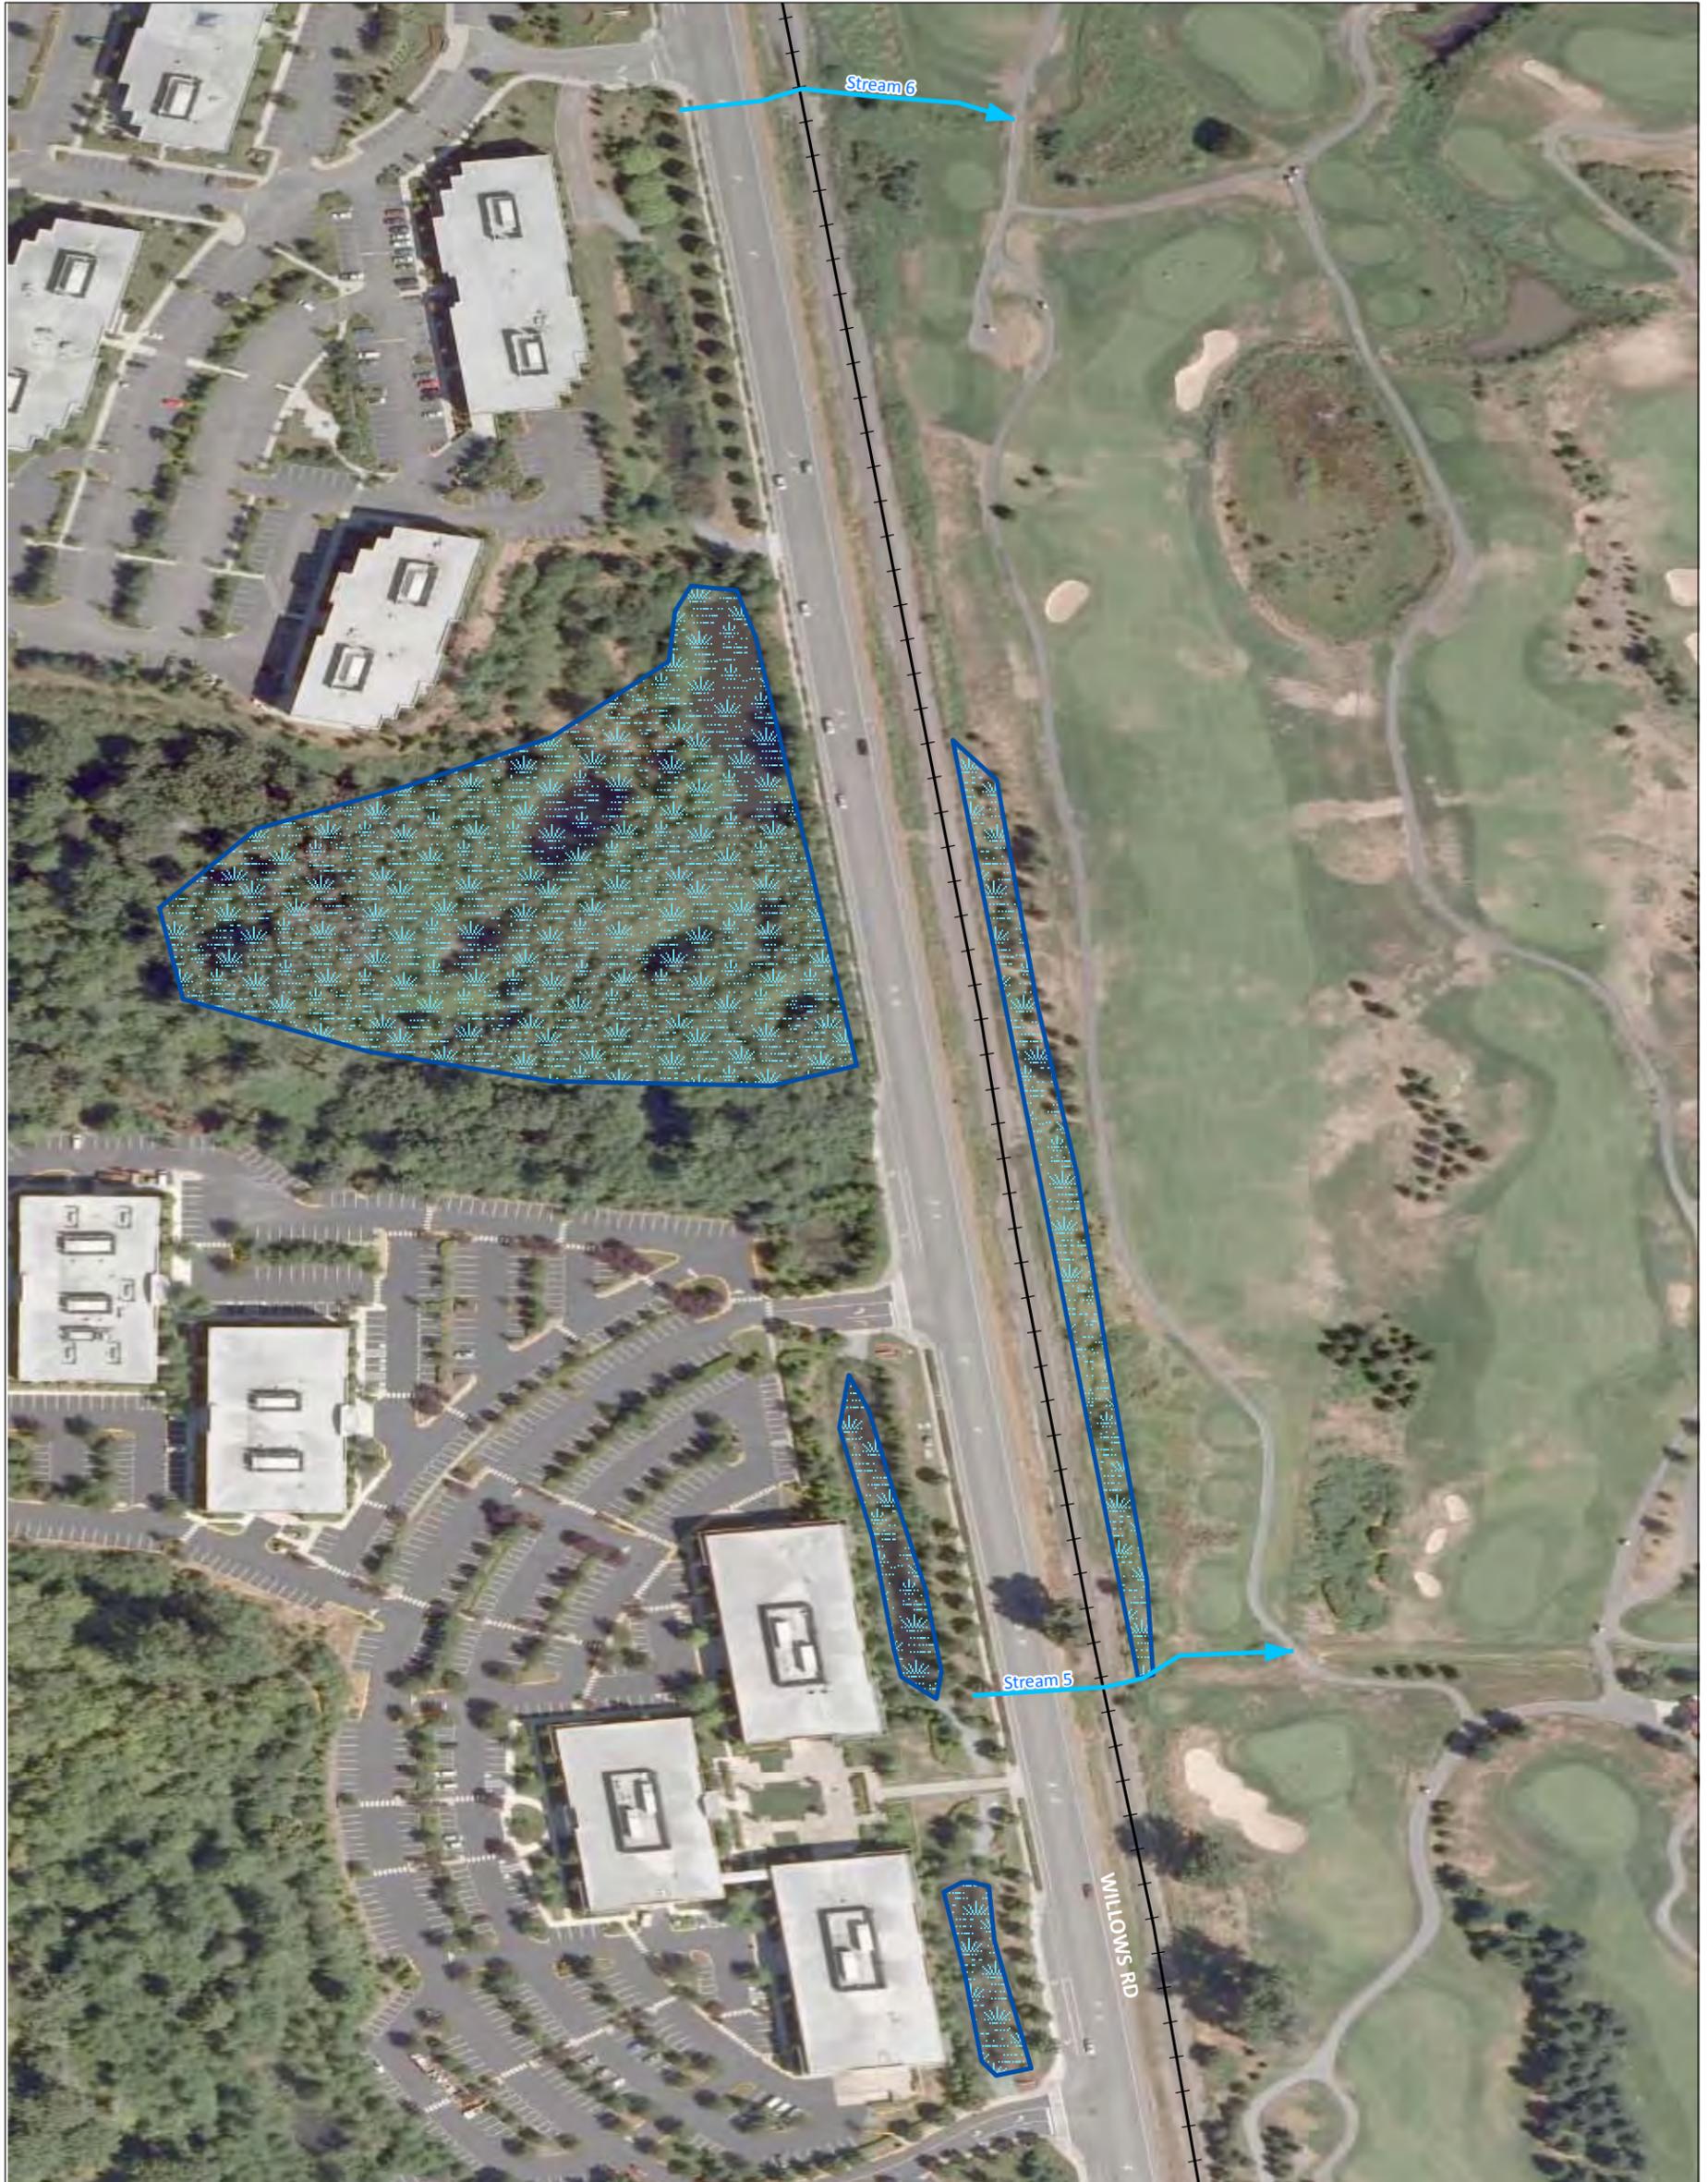
BNSF Rail Corridor Critical Areas Reconnaissance	
Redmond, Washington	
GEOENGINEERS	Figure 7

In the northern portion of the corridor, we observed wetlands in the low-lying areas east of ROW. This area includes the pastureland between Northeast 124th Street and Northeast 116th Street; and the Willows Run golf course (Figures 7 and 8). Depressional wetland conditions are primarily driven by shallow groundwater found throughout the Sammamish River Valley. One wetland located immediately east of the ROW and north of 116th Street (Figure 8) was identified and delineated by The Watershed Company (2009). We identified one potential wetland feature that abuts the ROW west of the Willows Run golf course (Figure 7). The regulated buffers of these wetlands will project into the ROW.
