Rose Hill Subdivision

Preliminary Drainage Report

April 2016

Jeremy Febus, PE, LEED AP
KPFF Consulting Engineers
1601 Fifth Avenue, Suite 1600
Seattle, WA 98101
(206) 622-5822
KPFF Project No. 115283.20

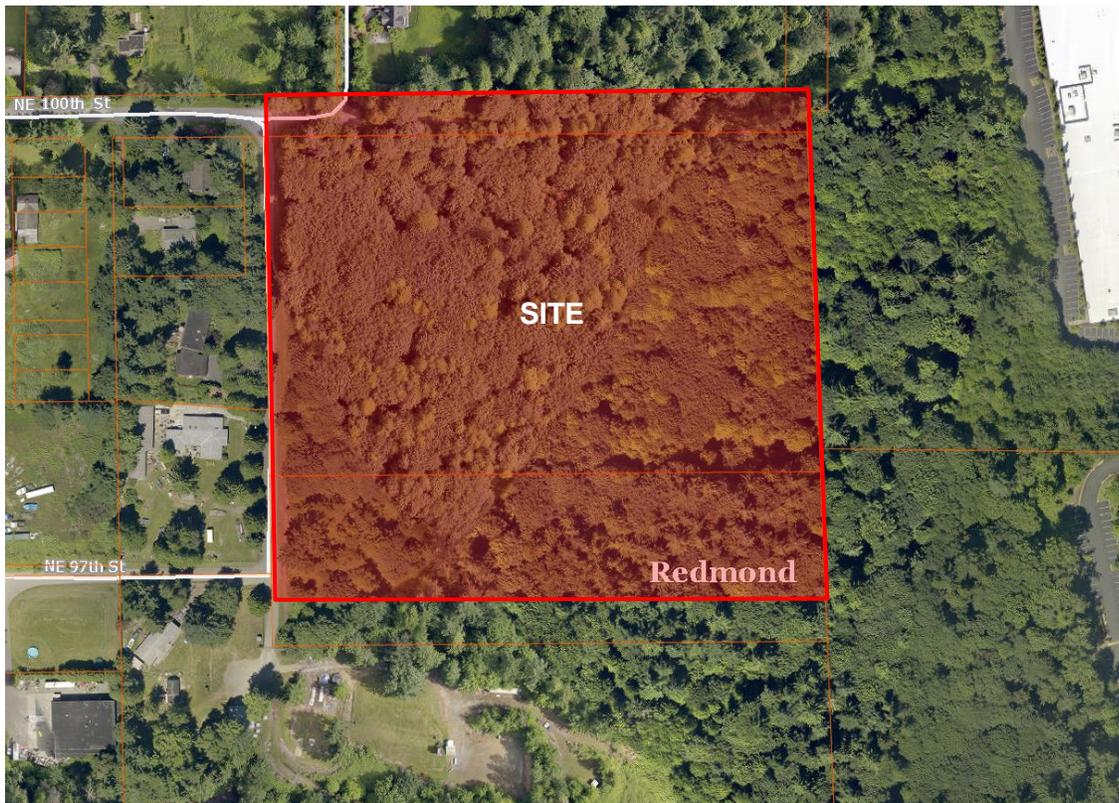
Figure 1-1: Site Map (King County Imap)

The Rose Hill Subdivision is a proposed 29-lot residential development. The proposed development is located at the southeast corner of the intersection of Northeast 100th Street and 138th Avenue Northeast, in Redmond, Washington. The site is currently undeveloped, and is comprised of two parcels totaling approximately 13 acres (Figure 1-1). This report is intended to support the preliminary stormwater facility design and mitigation for the proposed development. A final report will be submitted with construction documents following preliminary plat approval.

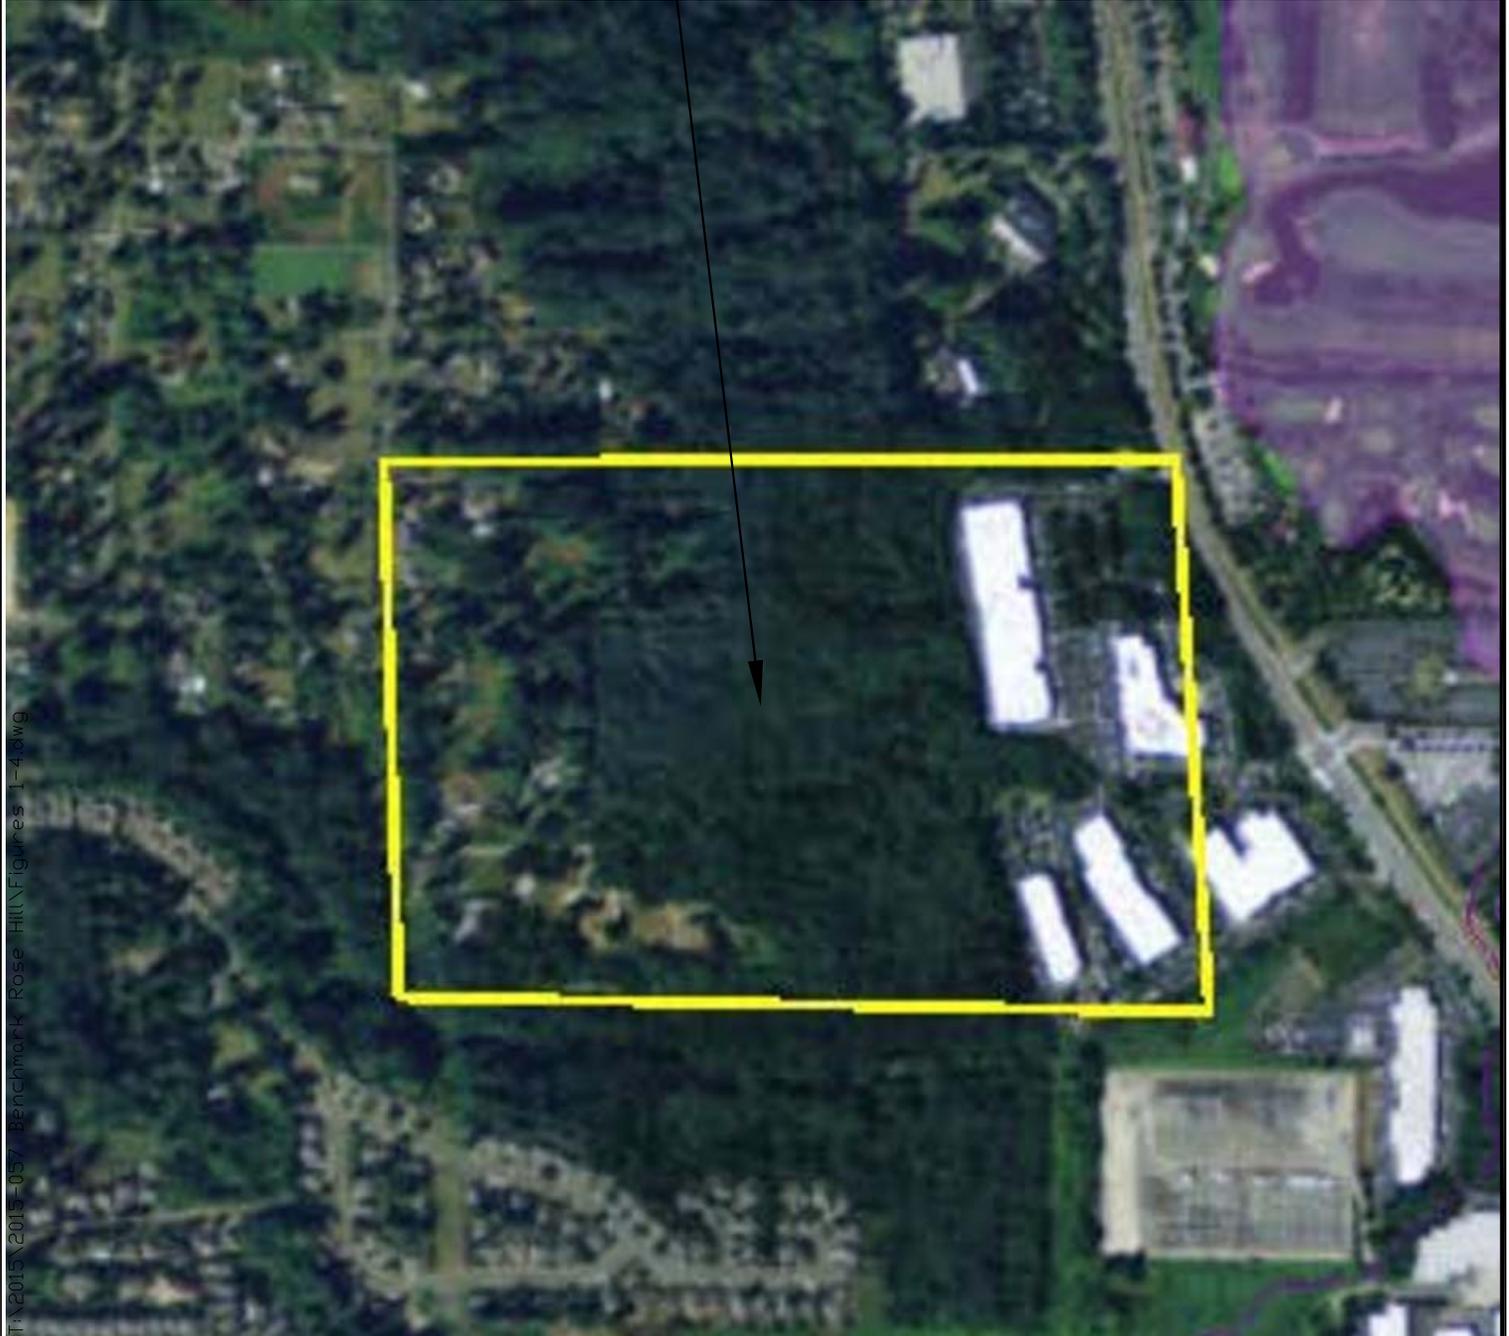
FIGURE 2
SOILS MAP
BMC ROSE HILL LLC
REDMOND, WA

Source: Soil Survey Staff, Natural Resources Conservation Service, United States Department of Agriculture. Web Soil Survey. Available online at <http://websoilsurvey.nrcs.usda.gov/>. Accessed [2015/9/23].
